**Ashton-in-Makerfield**  
Conservation Area Appraisal

# Ashton-in-Makerfield Conservation Area Appraisal

When formally adopted this document will be a Supplementary Planning Document (SPD). It provides guidance on how to meet the requirements pertinent to the management and protection of the Ashton-in-Makerfield Conservation Area.

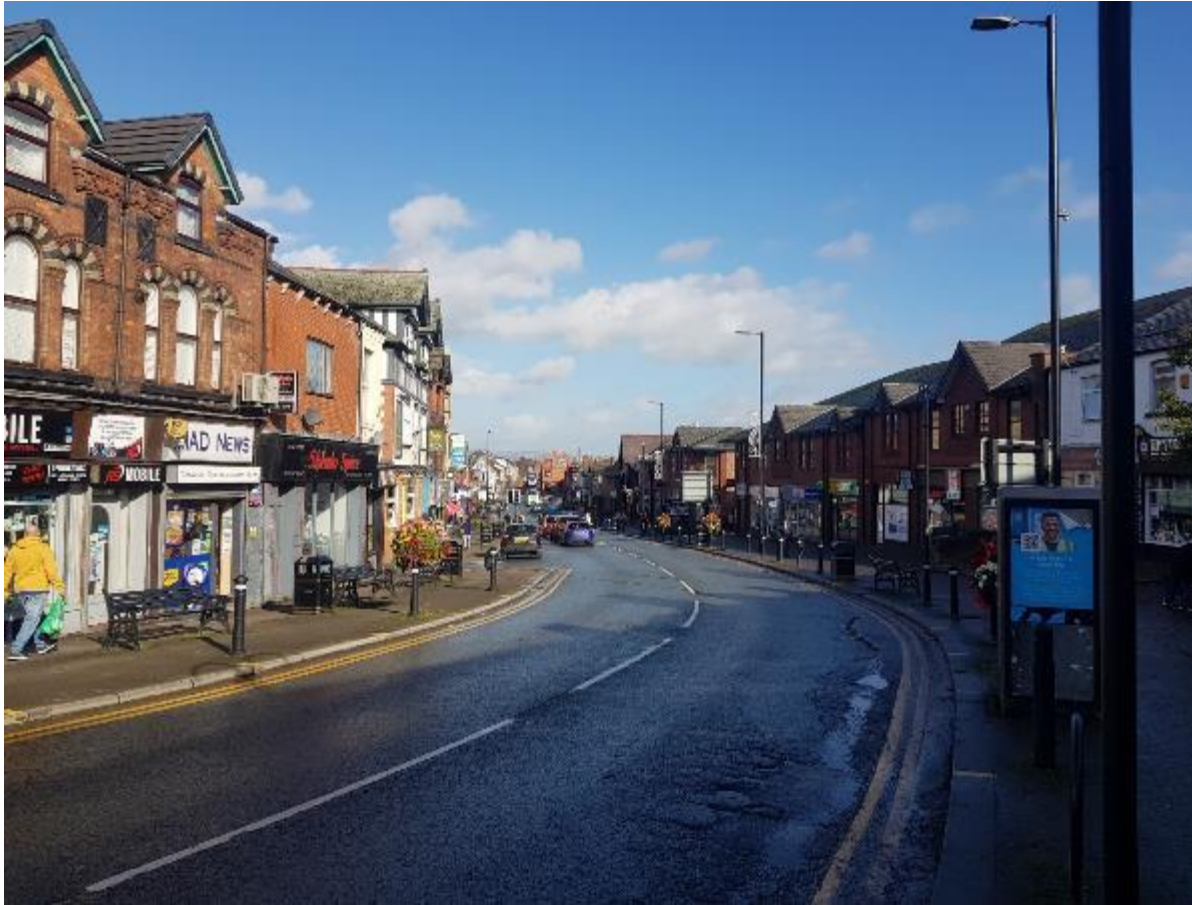
Picture 5. View north along Gerard Street showing land sloping down towards the junction with Princess Road

1.16 Gerard Street is the principal street of the town and has an unusual curved form as it rises up the hill. This provides an important focal point for the conservation area. There is a secondary focal point on Warrington Road at the approach to the junction near the Kings Arms where St Thomas Church and the historic buildings mark the entrance to the town centre.

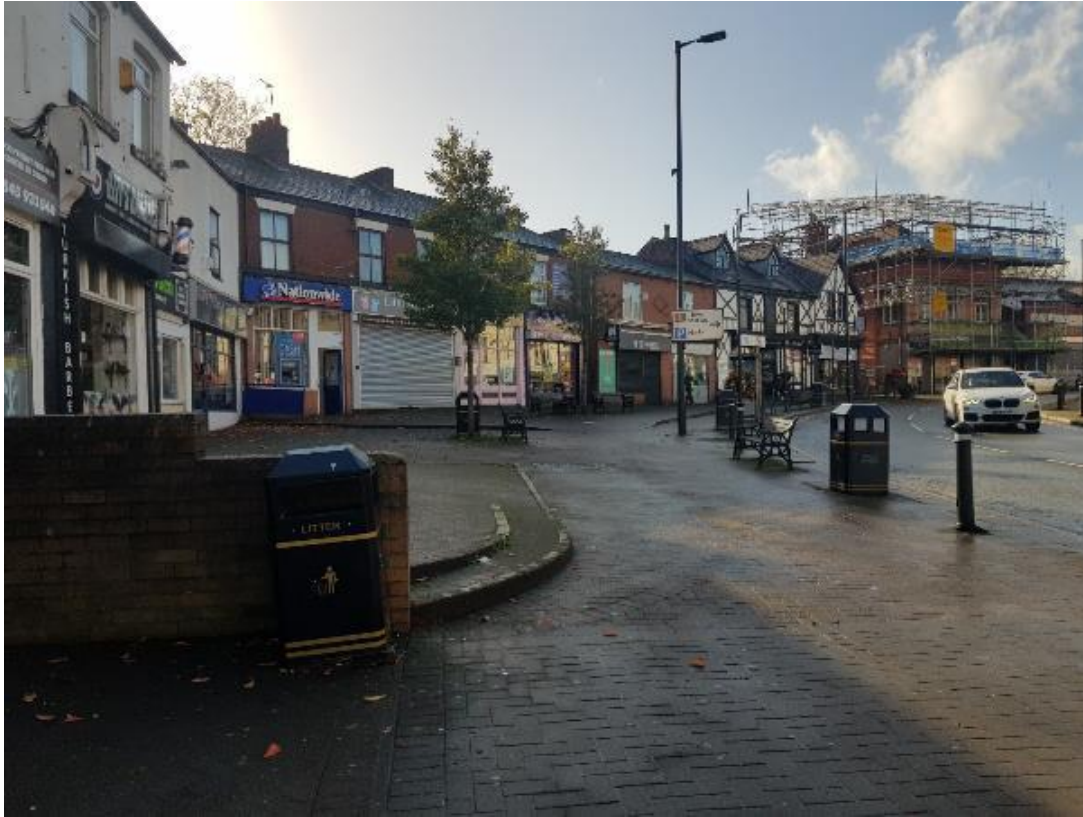
Picture 6. The bend in Gerard Street towards the apex of the hill is a notable feature of the streetscape

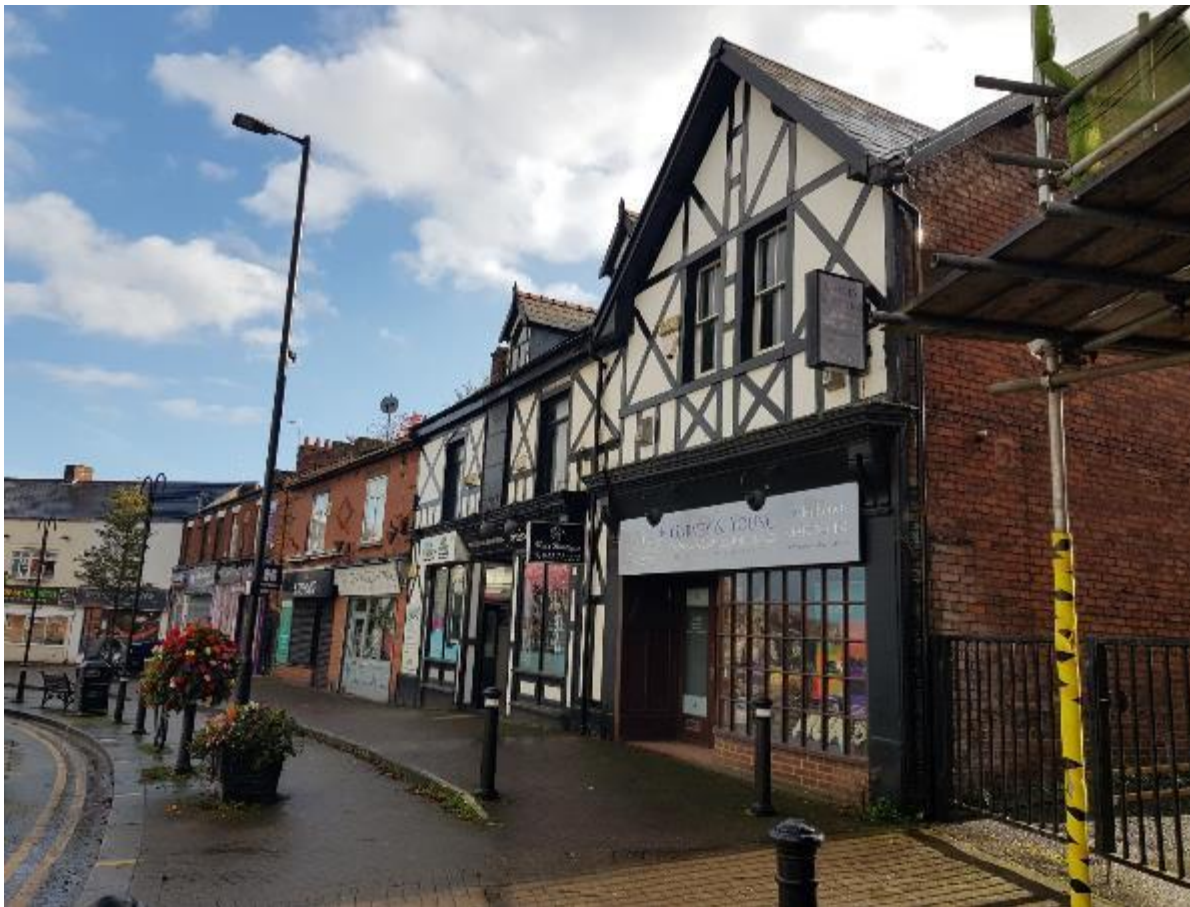
Picture 8. Most properties are Victorian of varying styles and quality.

2.1 The majority of properties in the conservation area are Victorian, dating from around 1850 until roughly the first world war. They range in styles from the plain and functional to the grand and decorative. There are also a smaller number of mid and later 20<sup>th</sup> Century properties of varying architectural merit.

2.2 Most non-public buildings are of 2 storeys in height rising to 2.5-3 storeys with front-facing gables, parapets and gabled dormers as common features. The variation of heights and treatments afforded by the dormers and gables create a pleasant and interesting roofline – especially to the western side of Gerard Street. It is notable that many historic features such as chimneys have been lost or truncated.

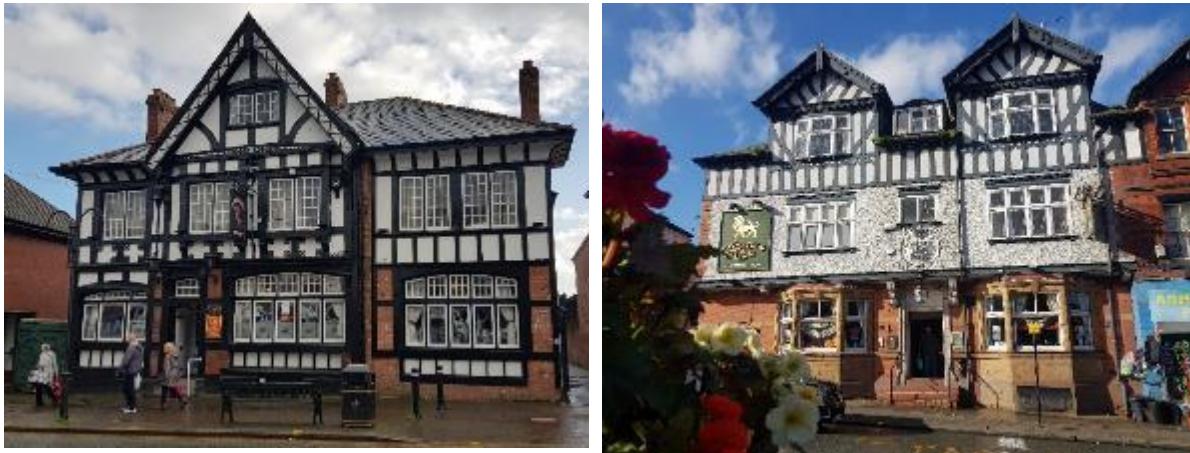
Picture 9. Public houses with ornate detailing including terracotta, faience and mock-Tudor timberwork.

2.4 Among the most characterful and ornate buildings in the conservation area are its public houses, whilst this is perhaps to be expected on the main roads it is notable that some of the backstreet pubs are also of historical and architectural interest.

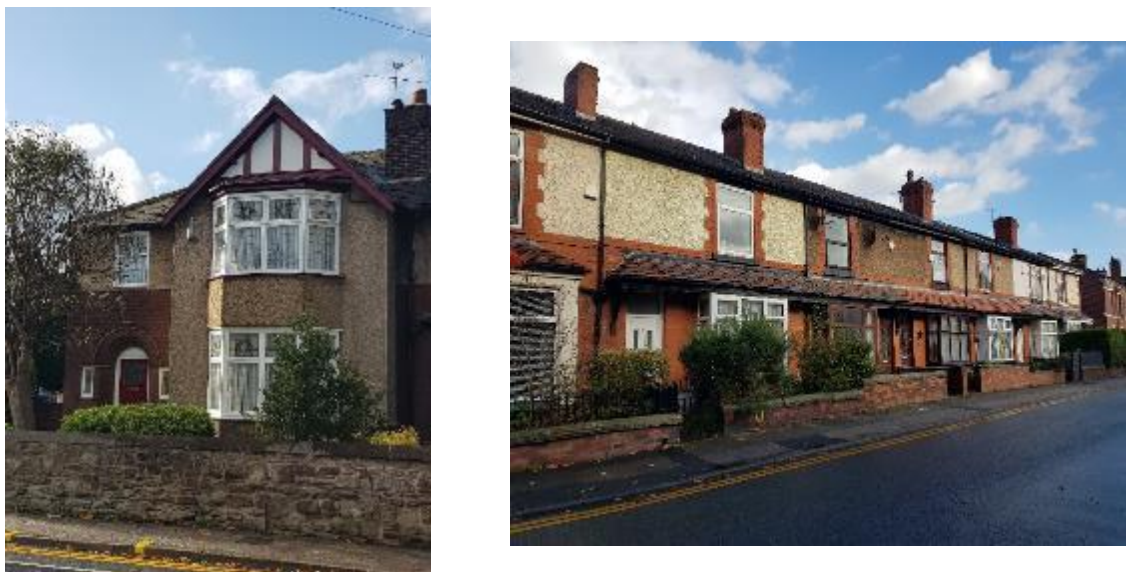
Picture 10. Residential streets have a variety of traditional forms.

2.5 The small residential streets of the conservation area are mostly red-brick terraces from the late 19<sup>th</sup> and early 20<sup>th</sup> century with slate-roofs, some of which have Edwardian style pebbledash and mock-Tudor cladding, particularly around St Thomas Church.

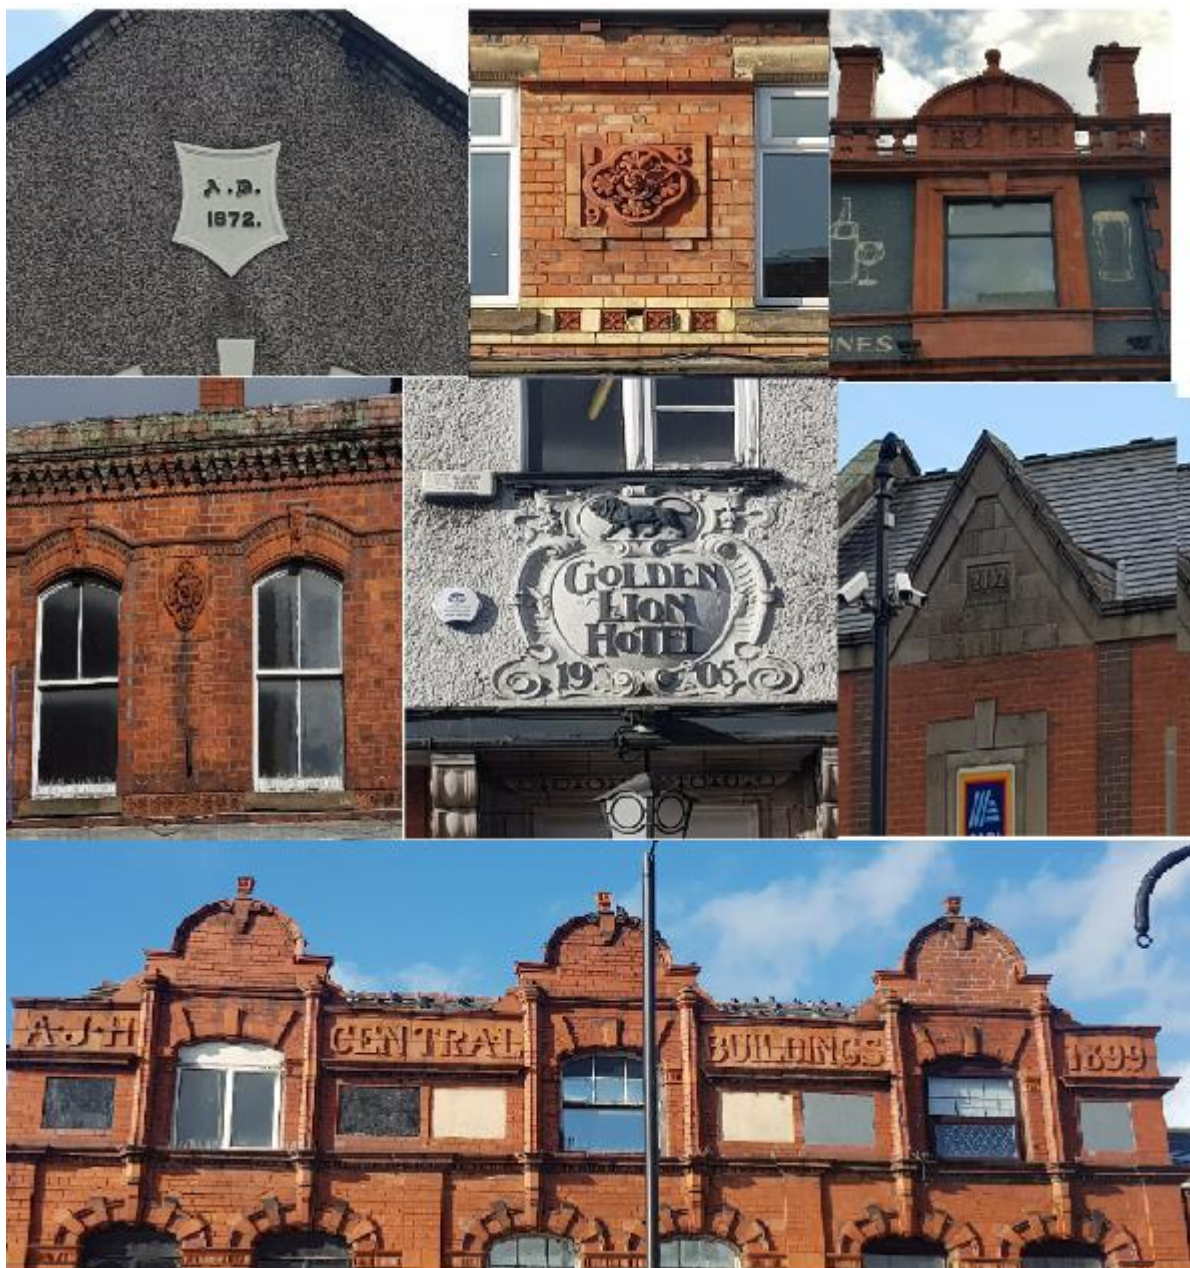
Picture 11. Decorative brickwork, strong-gables and decorative date-stones.

- Buildings are generally part of a terrace of up to 3 storeys high
- Slate or grey roofing materials
- Red brick buildings with decorative brickwork
- Use of strong front-facing gables and gabled-dormers
- Black and white mock-Tudor cladding
- Many buildings have decorative coats of arms, date-stones or patterned features on the front elevations.

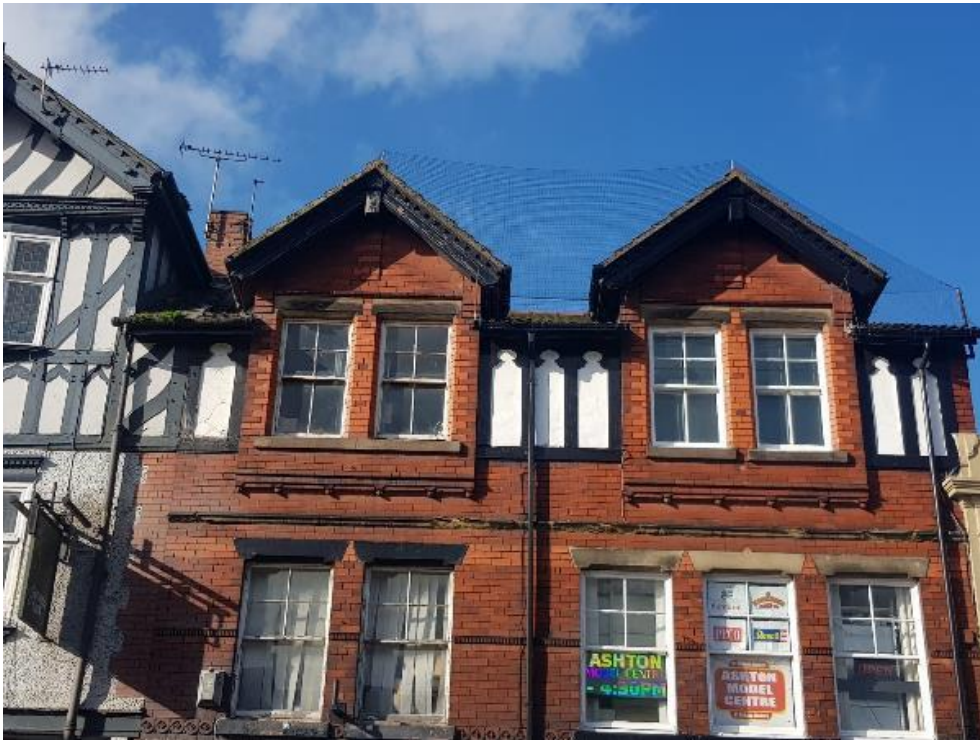
Picture 12. The area is typified by strong front-facing gables and gabled dormers.

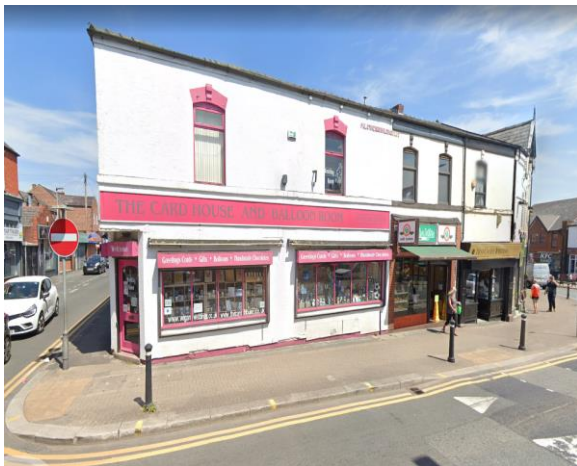
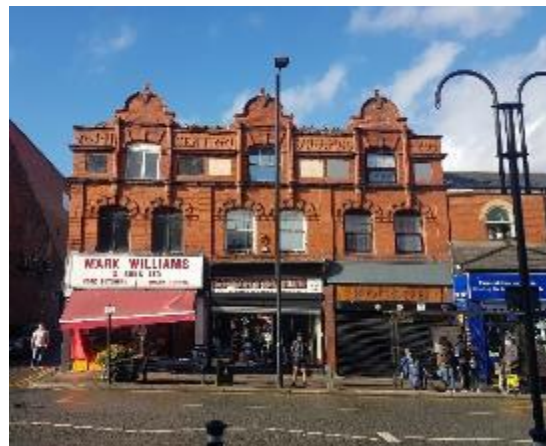
Picture 18. The relatively plain Palatine Buildings and the more ornate Central Buildings

3.5 The townscape reflects the sum of qualities of the building groupings within it. As the 19th Century progressed, the level of ornamentation and detailing increased. The earliest examples included the Palatine Buildings 1863, a simple two-storey commercial development where the detailing is limited to first-floor lintels and a corner doorway. Later commercial developments, such as the three-storey Central Buildings 1899, on the same side of Gerard Street, displayed extensive brick and terracotta detailing with exuberant window arches and parapet with name and date in large lettering.

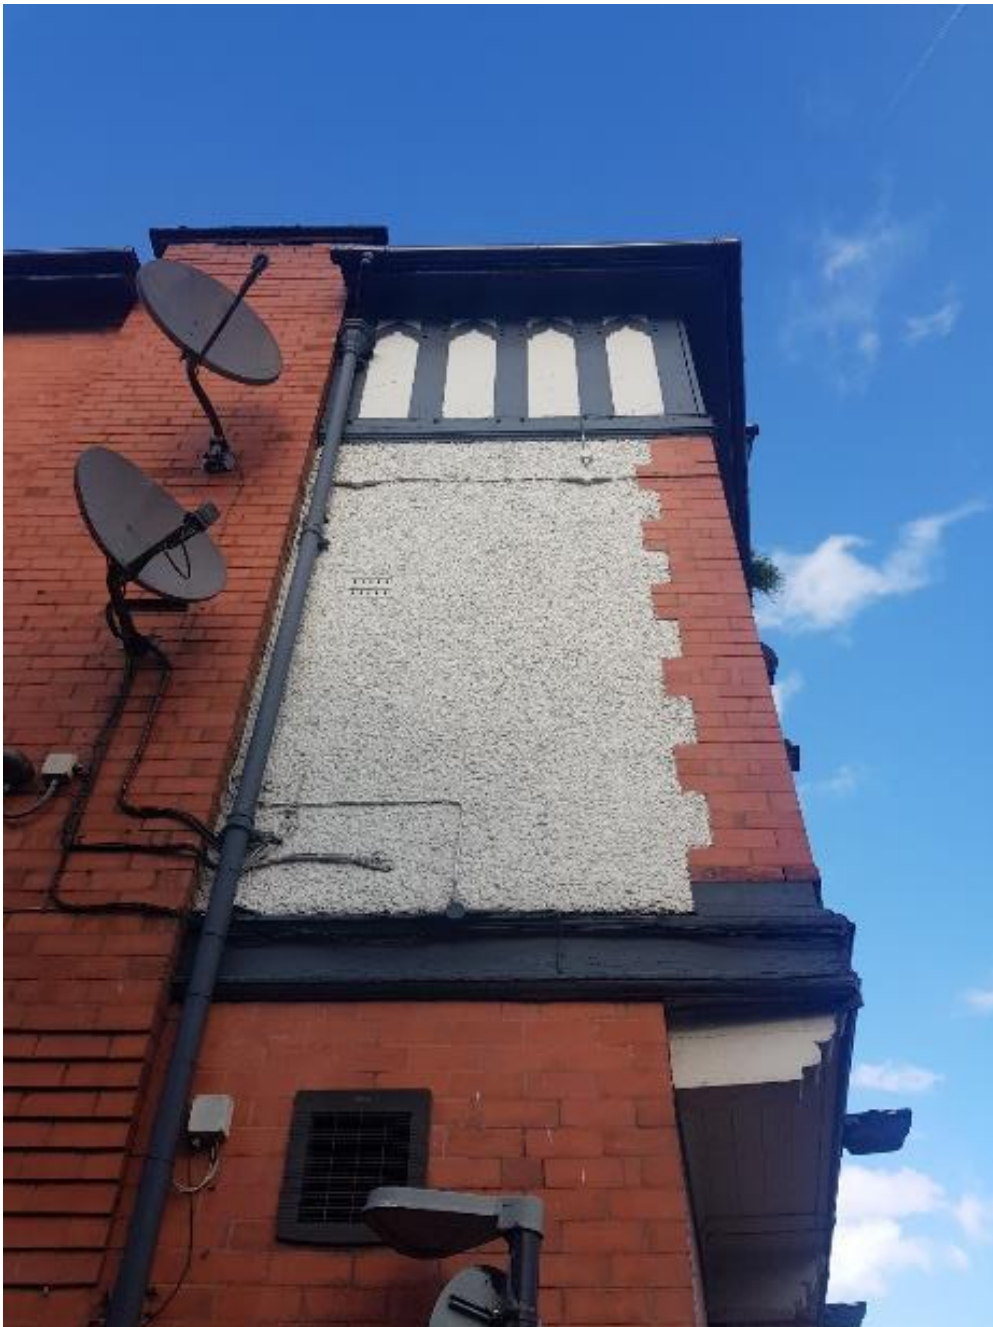
Picture 19. Brick, pebble-dash and mock-timbering are common materials in this character area, often on the same building.

3.6 Although it is difficult to identify a typical 'style' of architecture each building provides a special contribution to the area with its own character giving an organic feel to the town. The townscape mixture includes two and three storey buildings, most in brick but with some rendered with Edwardian-style harling, and others with mock timbering. Roofs are generally slate and windows tend to have stone lintels or decorative mouldings and surrounds.

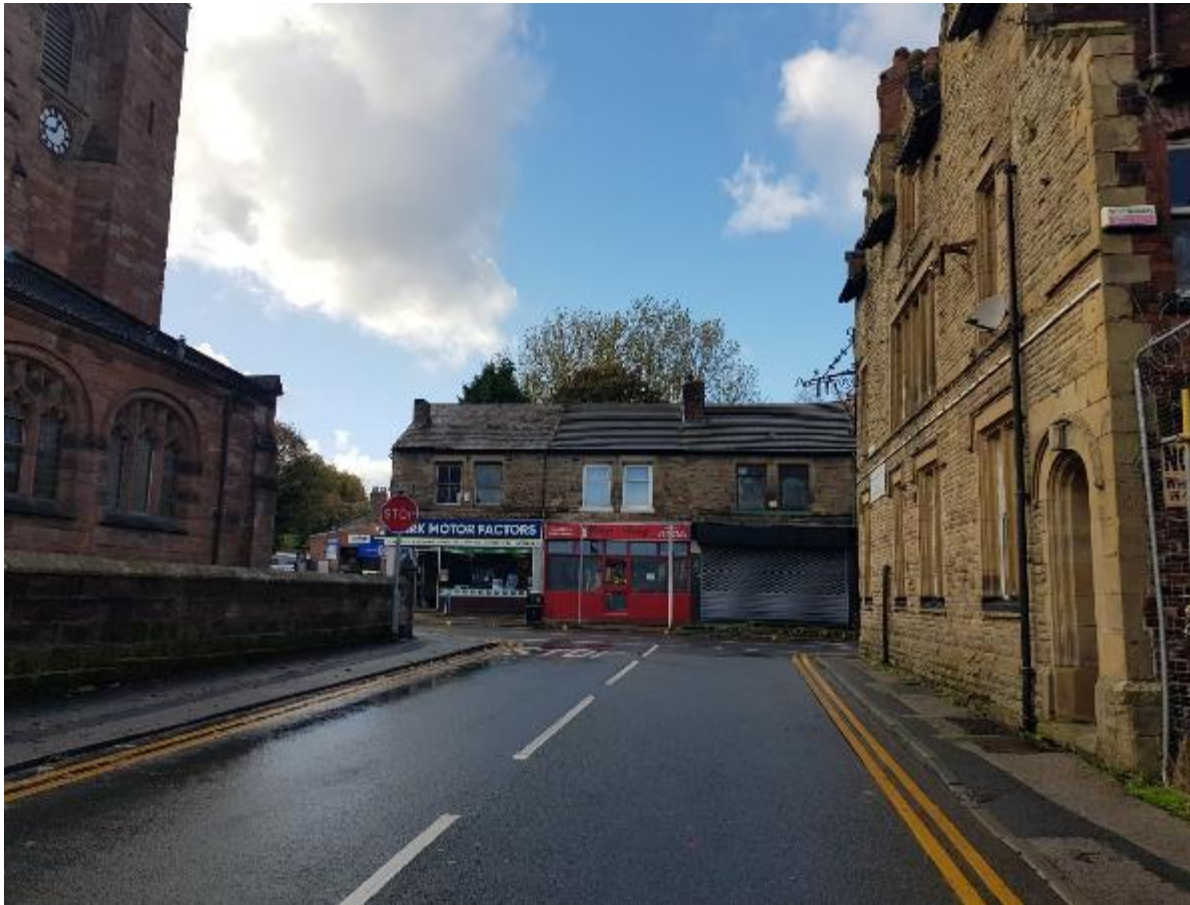
Picture 20. Local sandstone facing the buildings at Heath Road

3.8 The commercial buildings along the short length of Warrington Road included in this Character Area, repeat these themes including ornate public houses and public buildings. An additional point of interest is provided by the use of local sandstone facing on the buildings around the junction with Heath Road.

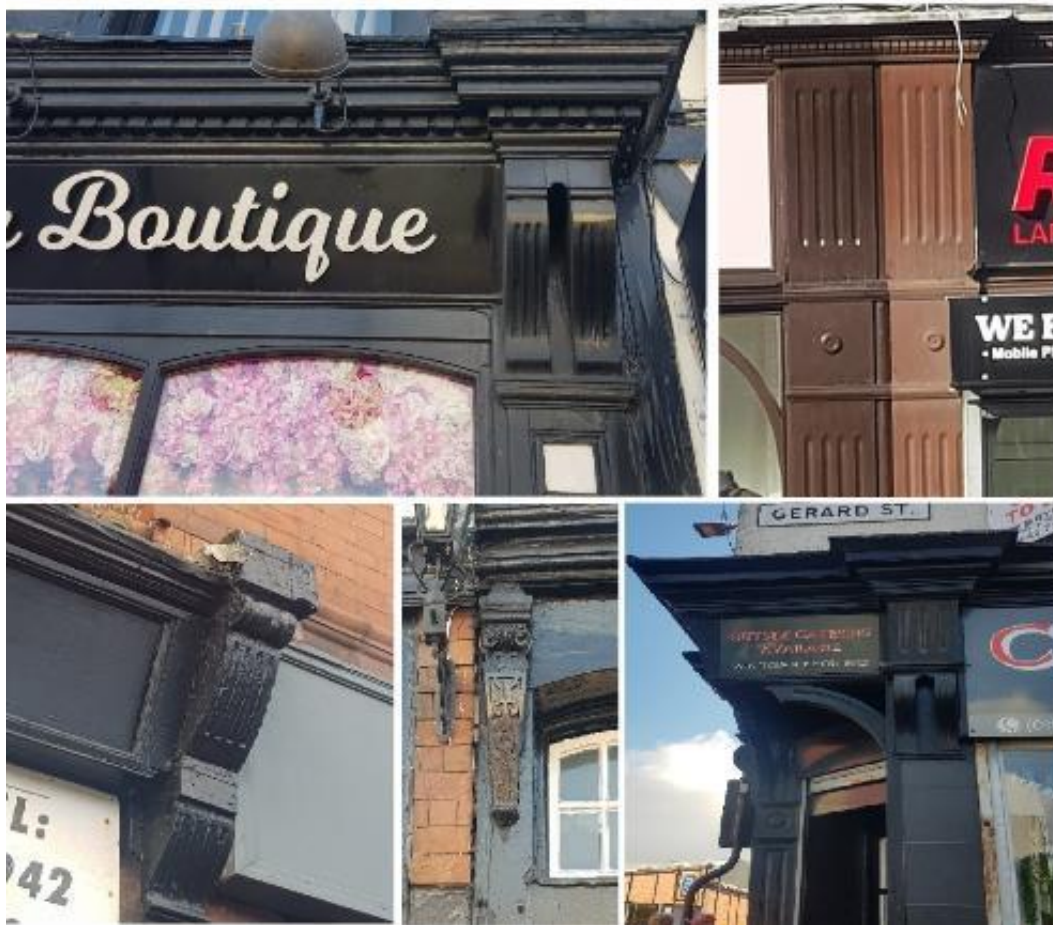
Picture 21: High quality shopfronts and details still survive in the conservation area.

3.10 There are a number of fine shopfronts retained in the area, although mostly hidden by modern interventions. Some of the most interesting are those around the Warrington Road/Gerard Street junction, specifically the Cooperative Hall building.

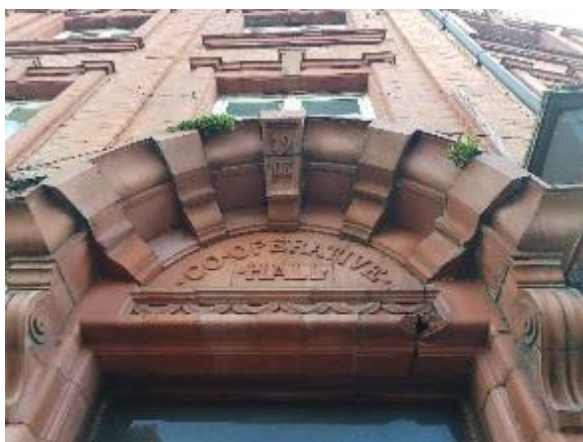
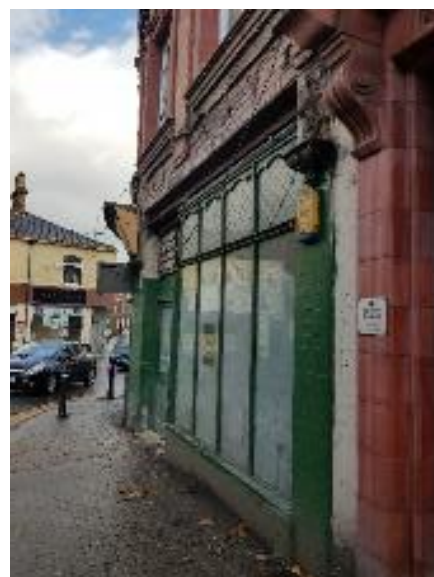
Picture 22: Shopfront and decoration at the Cooperative Hall.

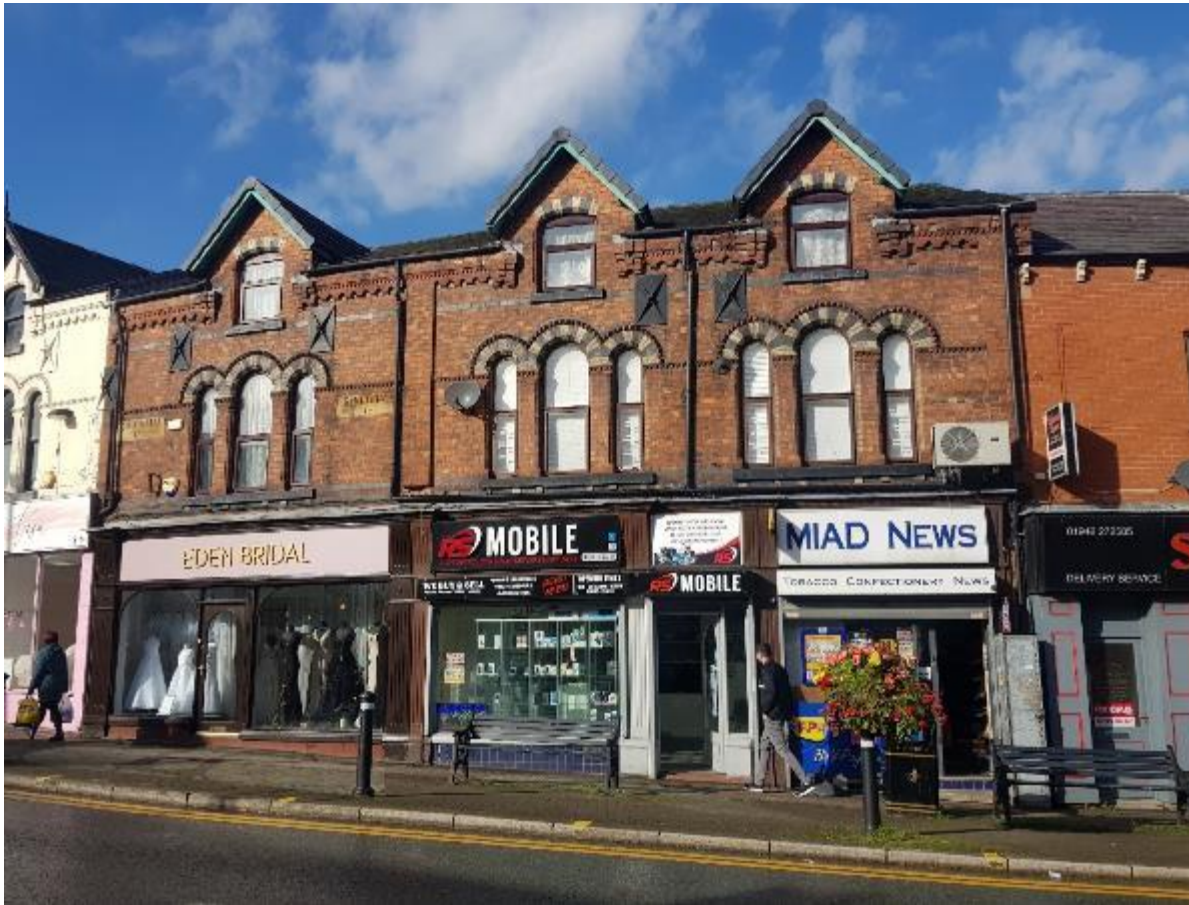
Picture 23. Poor quality shopfronts contrast and detract from above ground floor.

3.9 The form and structure of the architecture is attractive, especially above ground floor but the overall townscape is dominated by inappropriate and unattractive shop fronts and signage. Many of the key attributes of the area are undermined by poor quality ground floor façades.

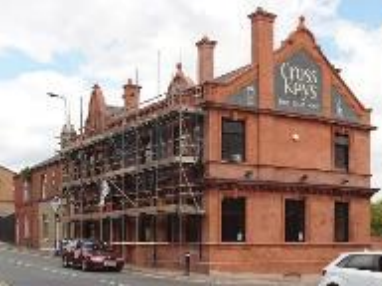
1. Former Armoury & Band House	2. The Cross Keys	3. Bridge Foot House

3.11 **The Cross Keys** dates from 1900 and is particularly noteworthy for its fine terracotta trimmings and decorative moulding. The roof has a terracotta balustrade with ornamental Dutch gables.

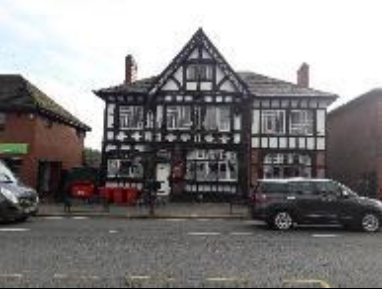
4. The Sir Thomas Gerard	5. The Red Lion	6. Central Buildings

3.14 **Red Lion** (1893) a fine example of a mock-Tudor public house, inspired partly by the arts and crafts movement this style of pub would evolve to become the notorious 'brewers tudor' for pubs of the 1930s. Nevertheless, this building is merit-worthy for its carved timber, including square-rose panels, decorative barge-boards and elegantly curved soffits continuing the mock-timberwork into the eaves. The right-hand bay is an early 2011 extension in a pleasingly complementary style.

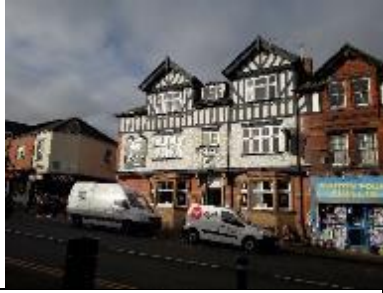
7. The Golden Lion	8. The Gerard Arms	9. The Kings Arms

3.16 The **Golden Lion** (1905) continues the mock-Tudor theme from the Red Lion. This is a grand building with jettied first and second floors. Black and white panelling at second floor, pebbledash at first and decorative fiance and terracotta bay windows at ground level. Above the door is an ornate plasterwork name panel.

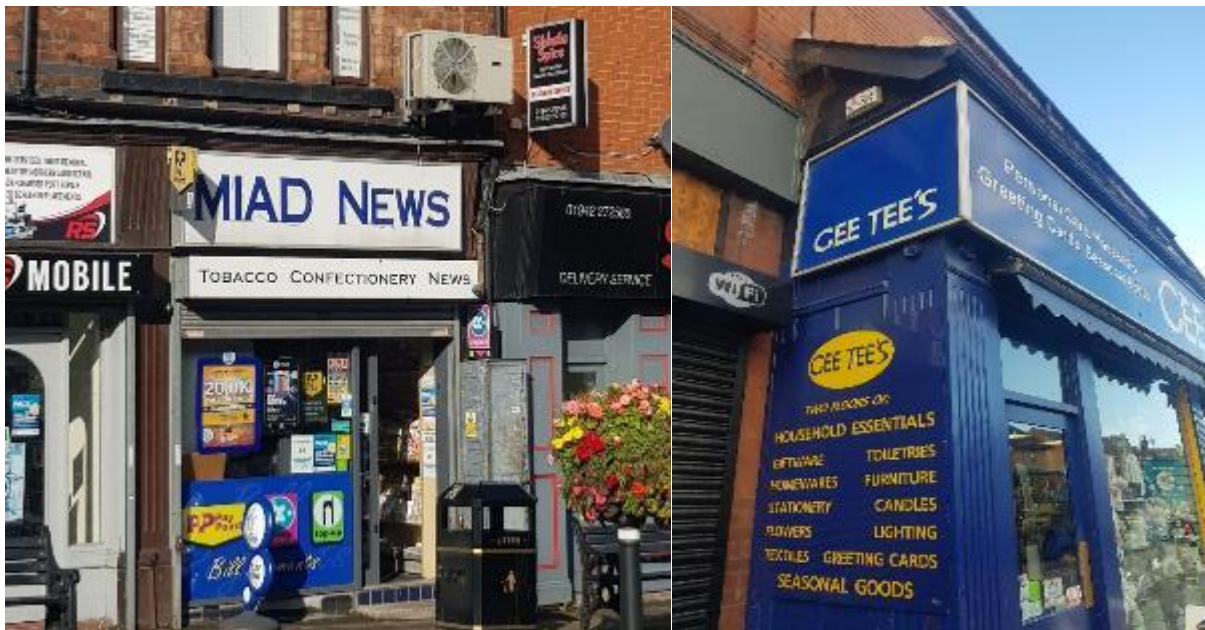
Picture 24. Poor quality shopfronts including dominant and unattractive signage, clutter and inappropriate attachments.

3.22 The main negative factor throughout this character area is the inappropriate and poor quality shop fronts often with loud and unattractive signage that detract from the qualities of the heritage buildings along most of Gerard Street. There are numerous examples of unsuitable materials and designs with unfortunate loss of heritage shopfront detailing and signage.

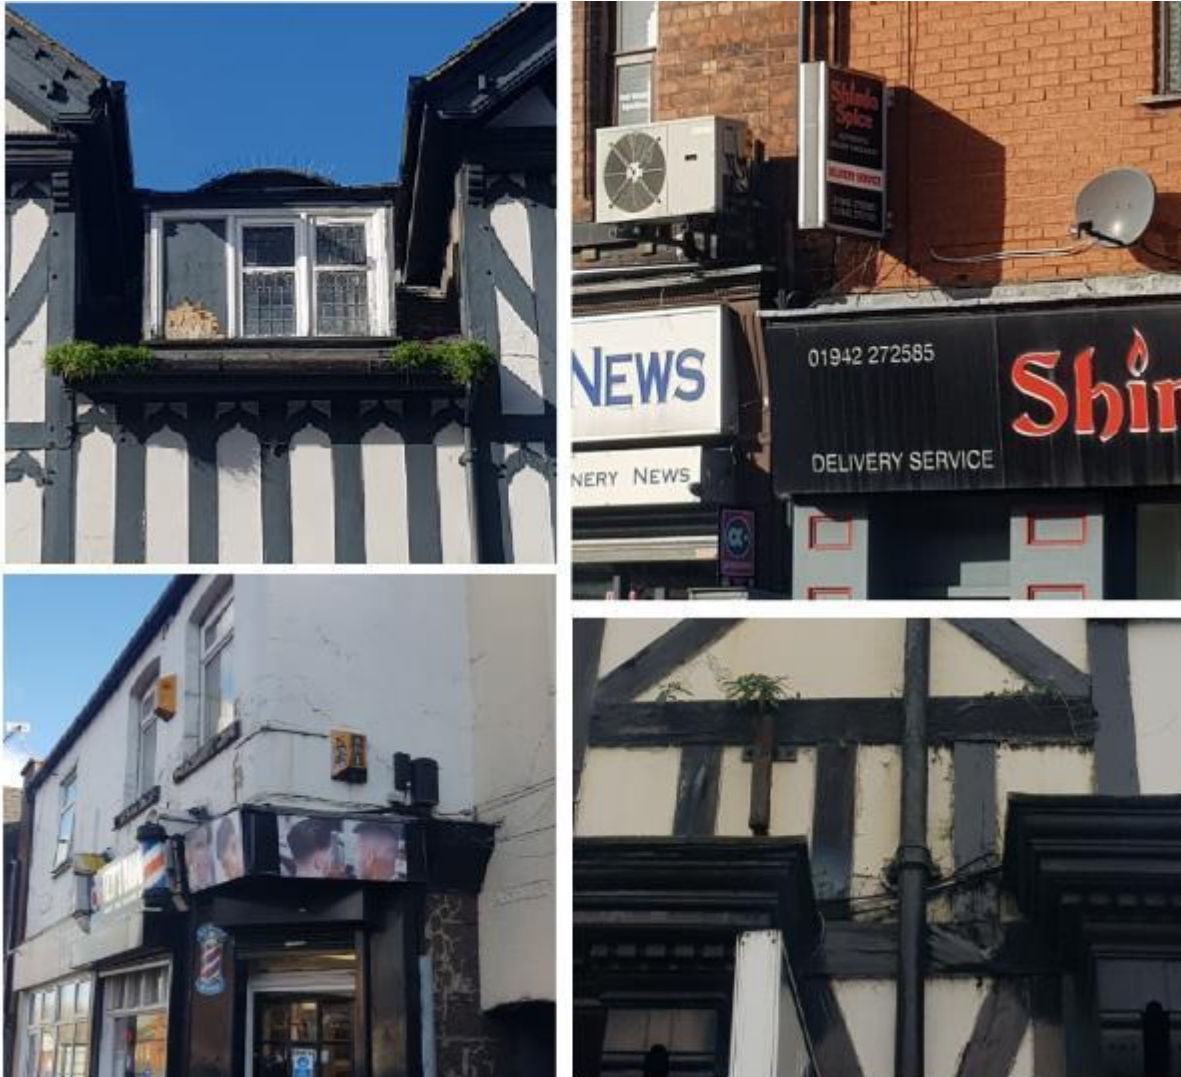
Picture 25 Clutter and poor repair is evidenced in the conservation area.

3.23 In addition, there is a generally poor level of maintenance and repair with evidence of plant growth, broken rainwater goods and poorly maintained fascias/windows/timberwork.

3.24 There is also a prevalence of 'clutter' throughout the conservation area. Satellite dishes are the most prominent incongruous feature, but other features such as the front-mounted air conditioning unit on 48 Gerard Street also detract from the streetscape.

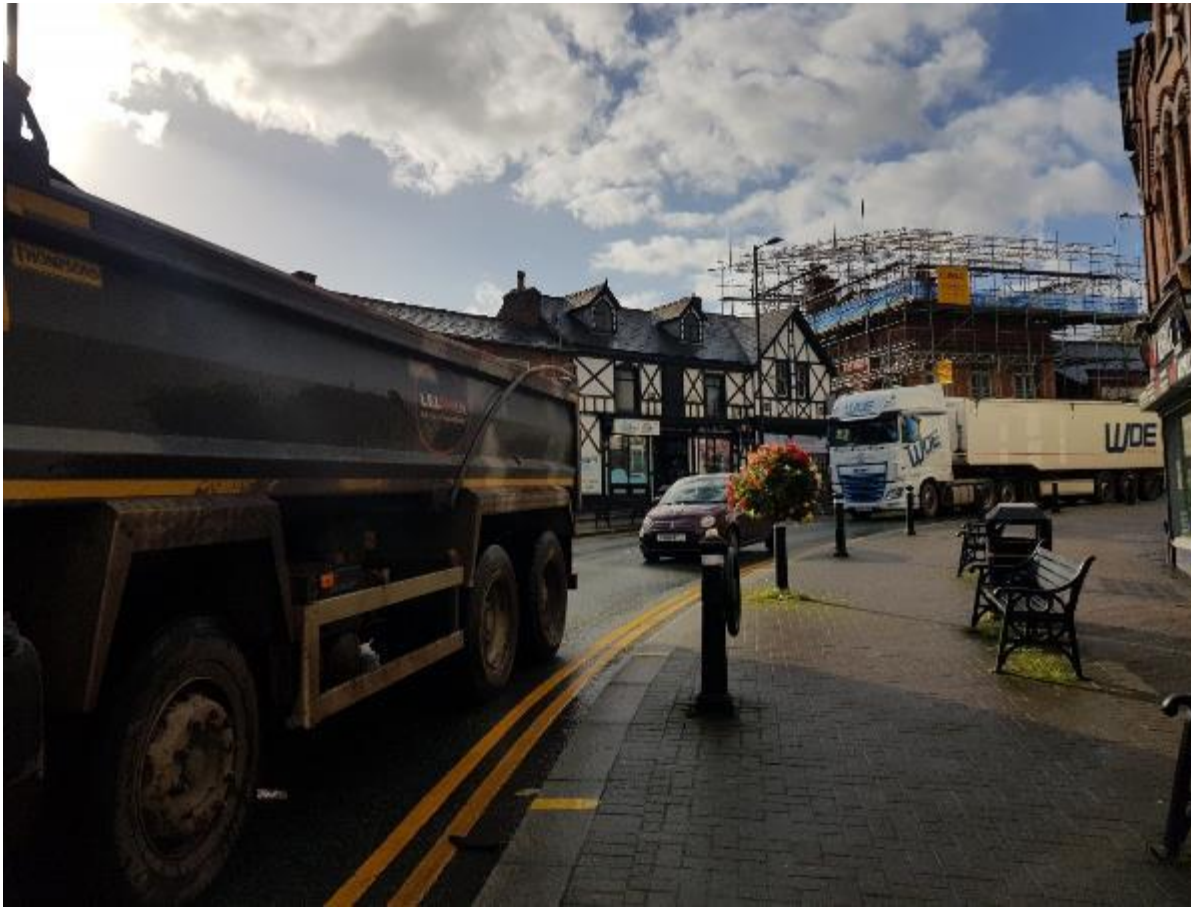
Picture 26. Vehicle traffic dominates the townscape, obscuring many views.

3.27 The other significant negative factor is the vehicular impact of through traffic – especially the numerous heavy lorries. Not only does this erode the experience for shoppers who wish to hold a conversation or try to cross the road, but it detracts from the townscape qualities and the opportunity to appreciate the historic buildings. The resulting public realm is of poor quality.

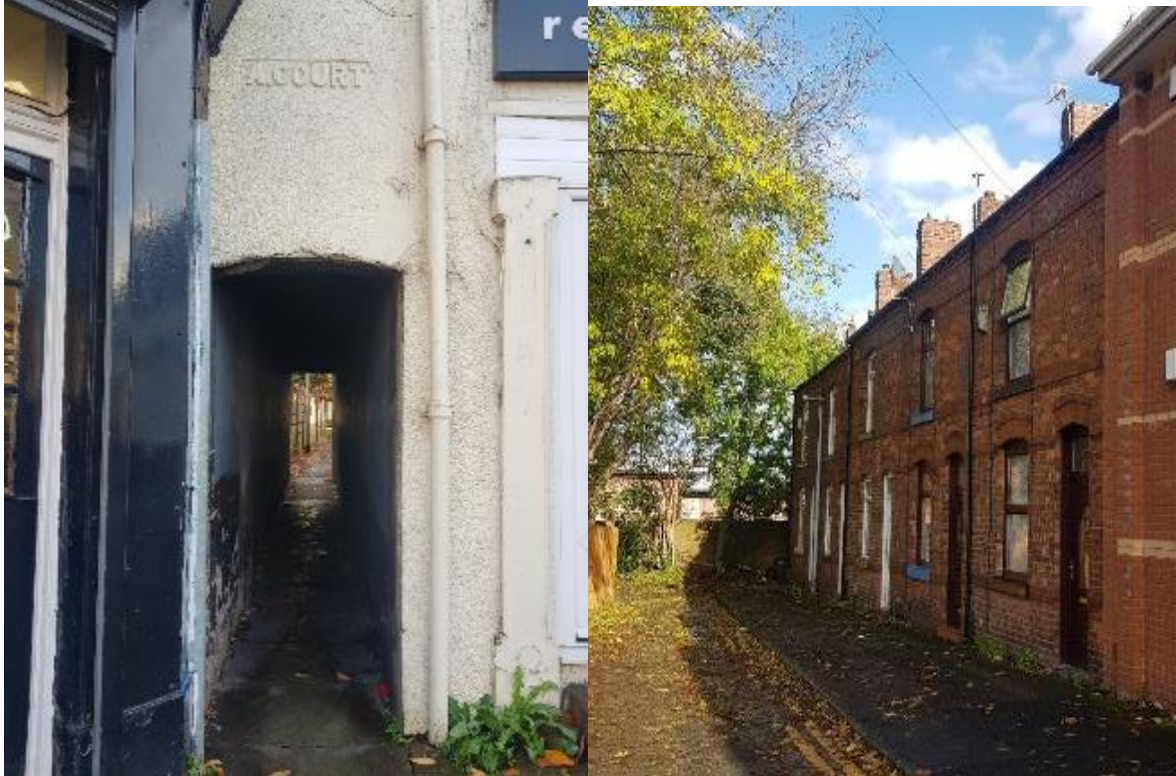
Picture 27 'Squeeze Belly Entry' from Gerard Street to 'A Court' terrace.

4.2 Of particular interest is 'A Court' a backstreet terrace of the late 19<sup>th</sup> century, linked directly to Gerard Street by an enclosed pedestrian passage. Old maps show there was once a number of similar passages in the town and this is the sole survivor. It is known locally as 'Squeeze Belly Entry'.

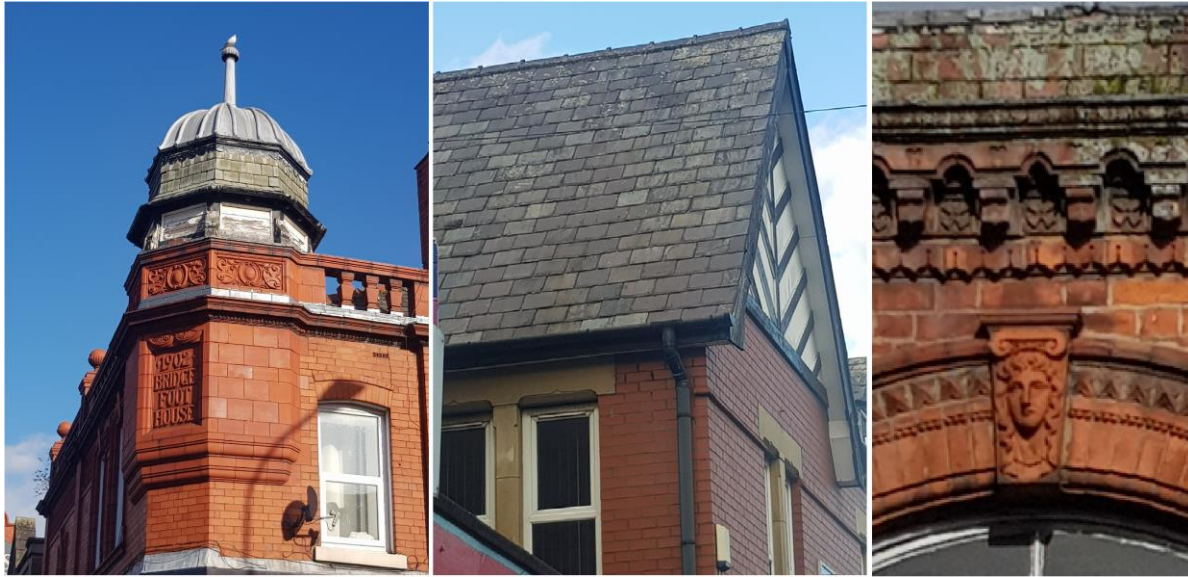
Picture 28. Red brick and slate roofs and decorative brick detailing.

4.5 The dominant materials are red brick with slate roofs. The earliest terrace in A Court is a very simple construction and design with basic three-dimensional brick details, and the later properties display more brick detailing and decoration and in the case of 1-13 Heath Street, include bay windows and rendering.

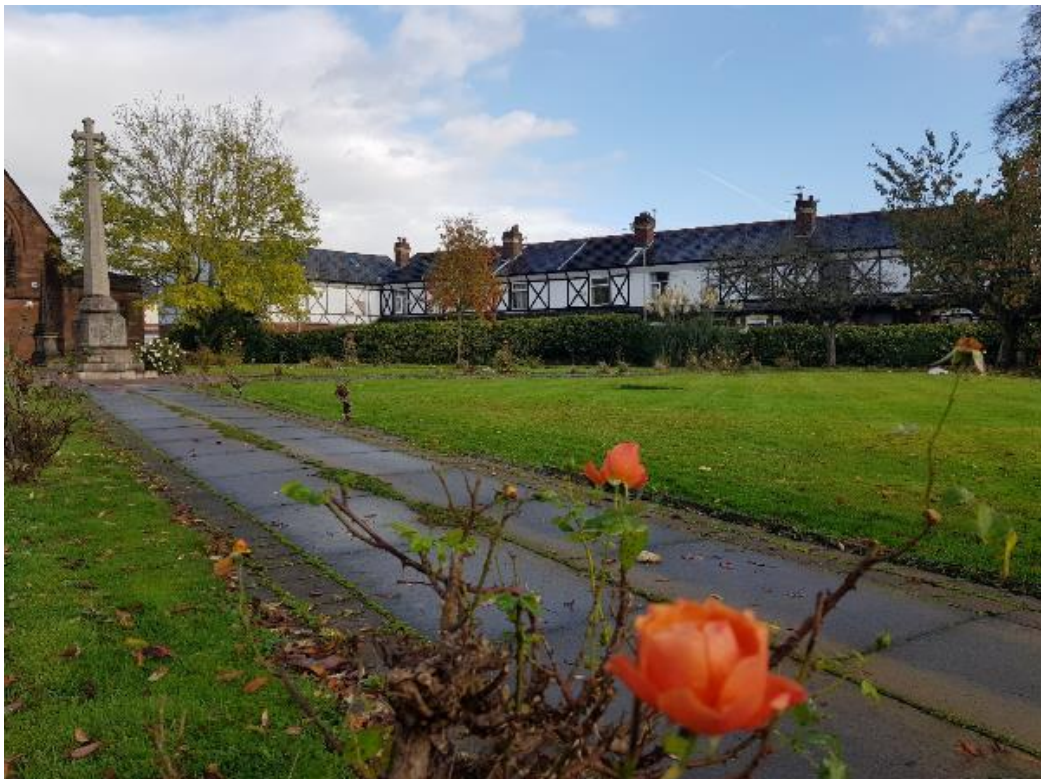
Picture 29. The late 19<sup>th</sup> century Church Terrace overlooking St Thomas Church.

4.6 The striking L-shaped terrace around the graveyard, Church Terrace, has rendered first floors with mock timber cross framed black boarding as decoration. A later terrace on Heath Road, facing the rear of St Thomas's, was probably designed with first floor rendered panels as decoration.

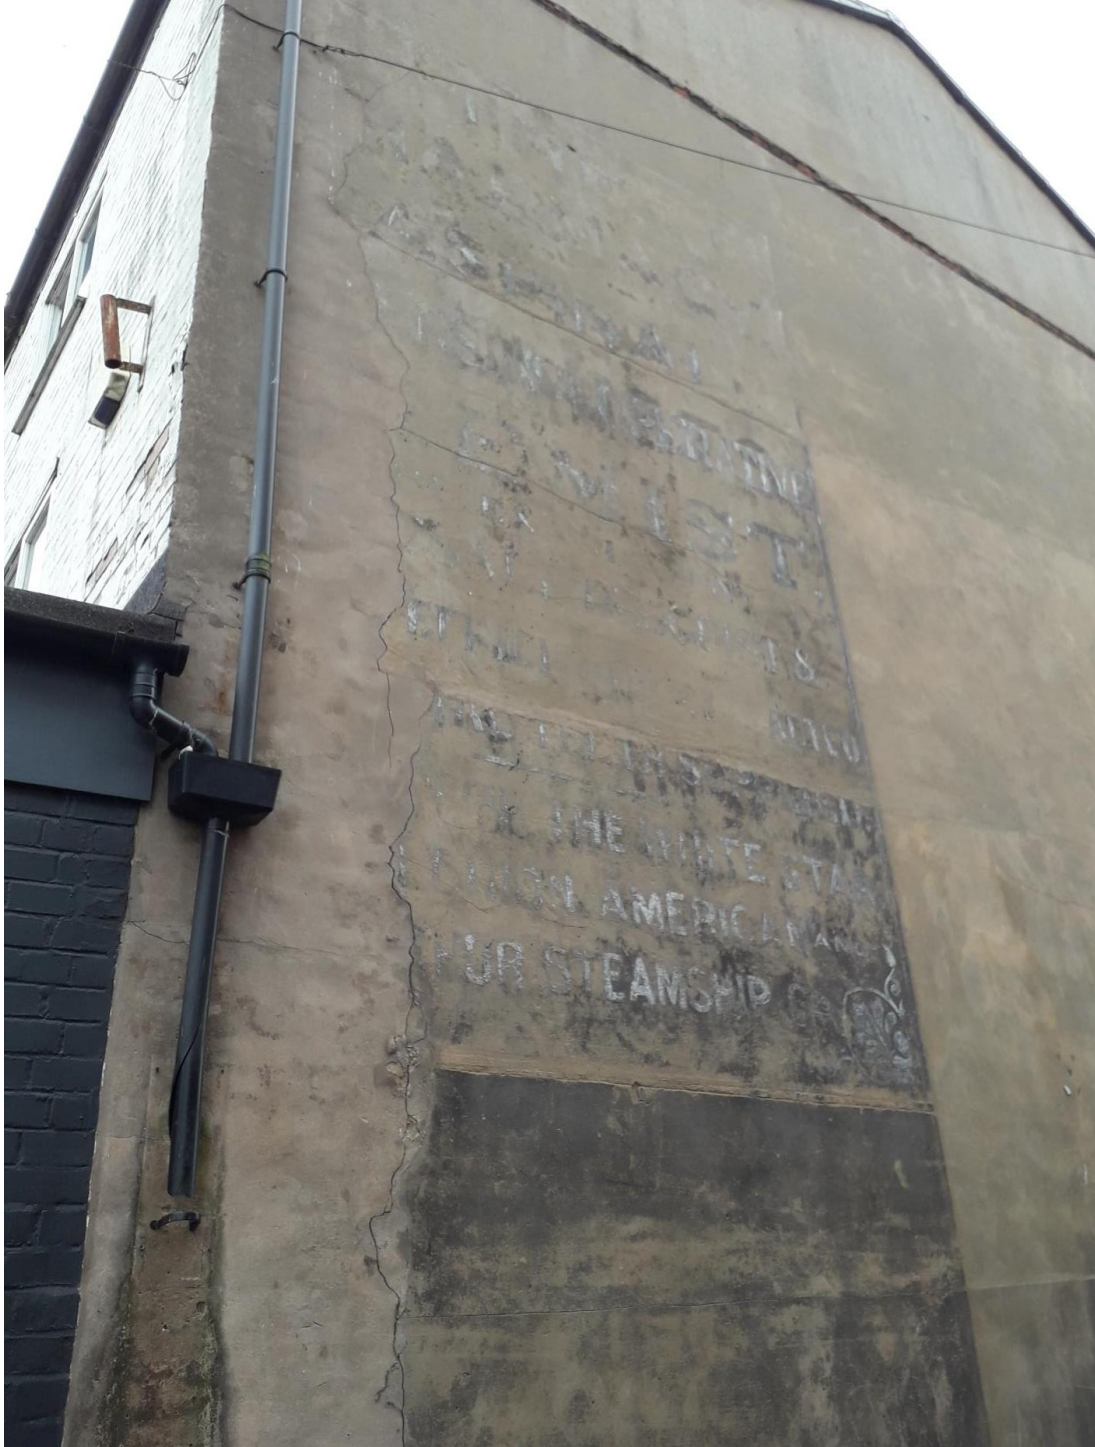
Picture 30. Traditional sign showing elements of textual and flower decoration.

4.7 There is some evidence of vestigial historic signage on Gerard Street. This appears to be an advert for William Apsinall, Chemist and Emigration Agent. This is a traditional form of signage and its

retention and if possible restoration would help restore historic character and could set a precedent for future advertisements in a traditional manner.

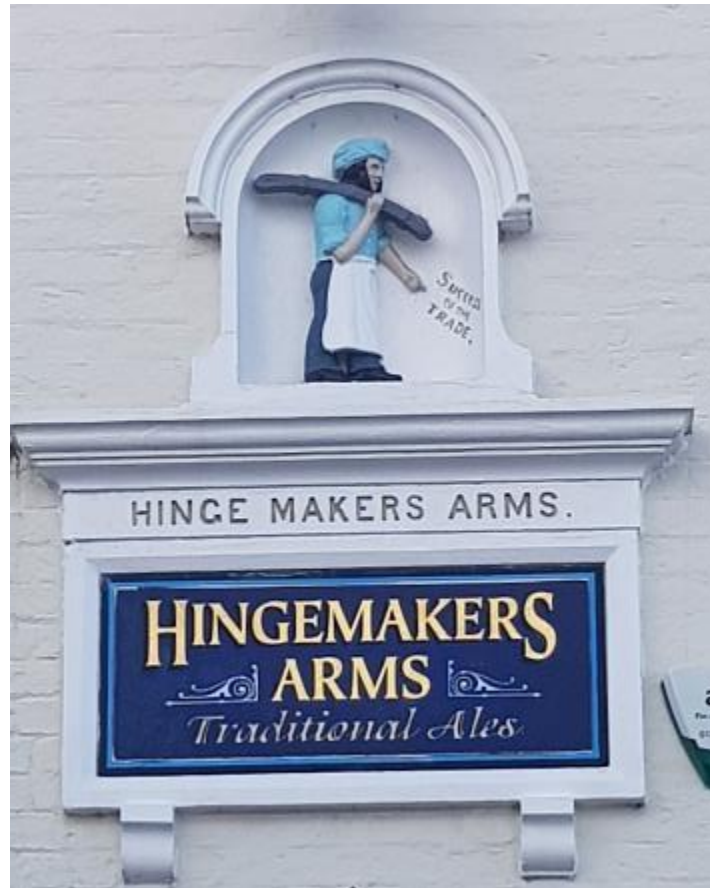
Picture 31. The Hingemaker – an historical industry in the area, as depicted in the sign for the Hingemakers Arms.

4.7 The **Hingemakers Arms** pub is an important reminder of the industry that once made Ashton famous. The building is relatively plain and lacks much of the ornamentation of other pubs in the area however, it is notable for the ornate statue/sign of the figure of a traditional hingemaker on the front elevation. It is reputedly the only pub of this name in the world.
