**Ashton-in-Makerfield**  
Conservation Area Appraisal

# Ashton-in-Makerfield Conservation Area Appraisal

When formally adopted this document will be a Supplementary Planning Document (SPD). It provides guidance on how to meet the requirements pertinent to the management and protection of the Ashton-in-Makerfield Conservation Area.

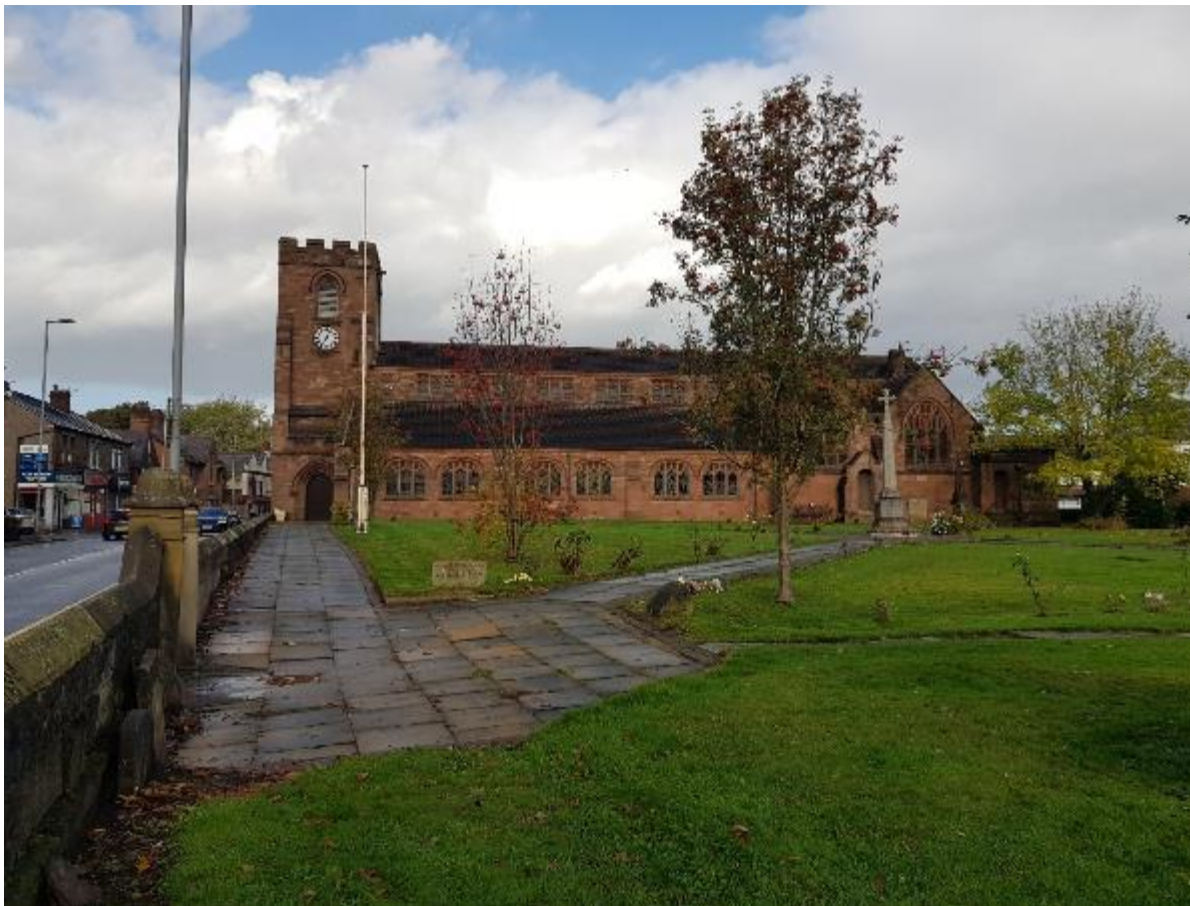
Picture 34 St Thomas Graveyard showing the sandstone walls and trees.

5.3 St Thomas's graveyard is bounded by a low stone wall which enables views from Warrington Road of the side elevation of the church. A fringe of trees reinforce these edges and provide structure within the graveyard by lining key pedestrian routes and framing the views of the church.

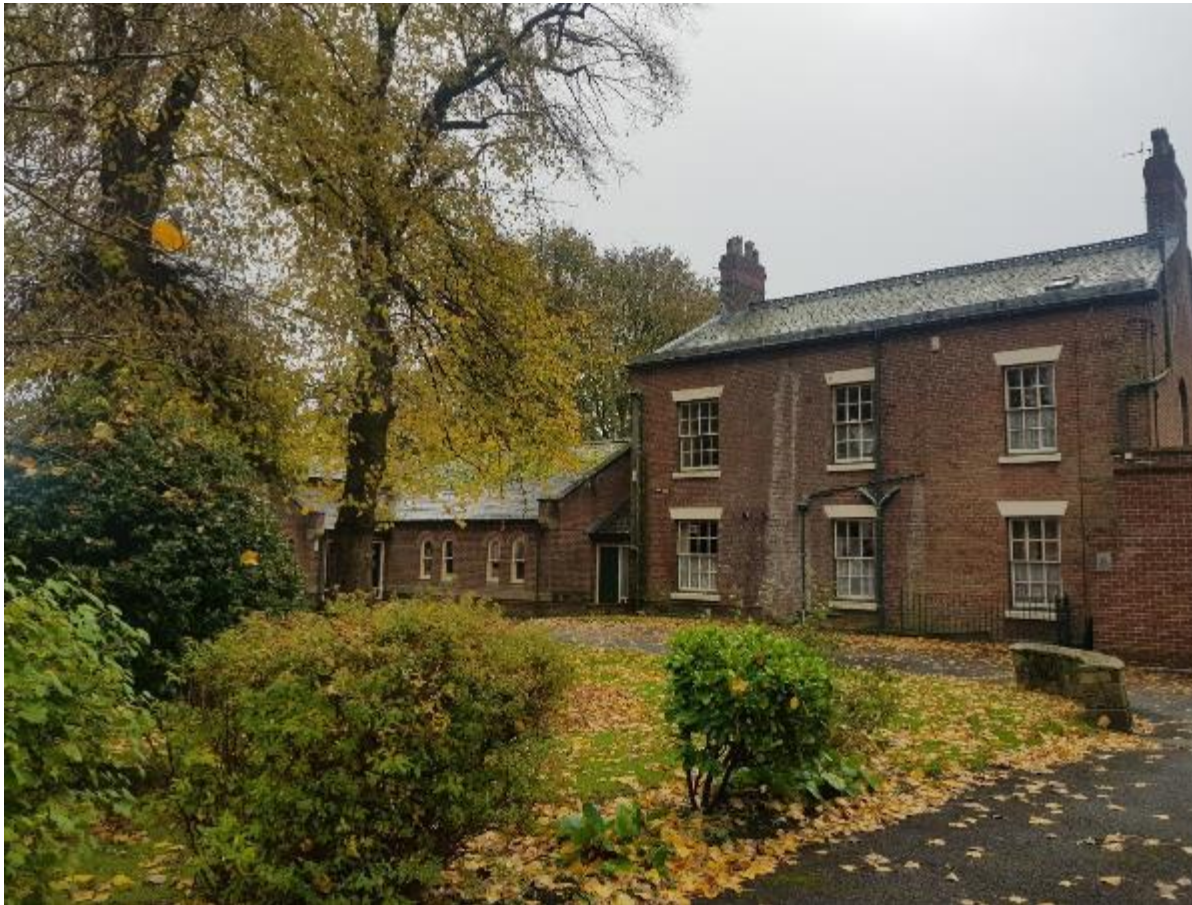
Picture 35. St Oswalds presbytery next to the church showing the enclosed grounds

5.4 In contrast, the large and dense lines of tree planting and high hedges which bound the more extensive grounds of St Oswald's creates a sizeable enclosure which is difficult to view from the surrounding roads. Though the church can be seen from its main drive, the summer foliage limits wider views of the graveyard and surrounding area. There is an unplanted part of the site that was formerly the community hall that is now utilised as car-park.

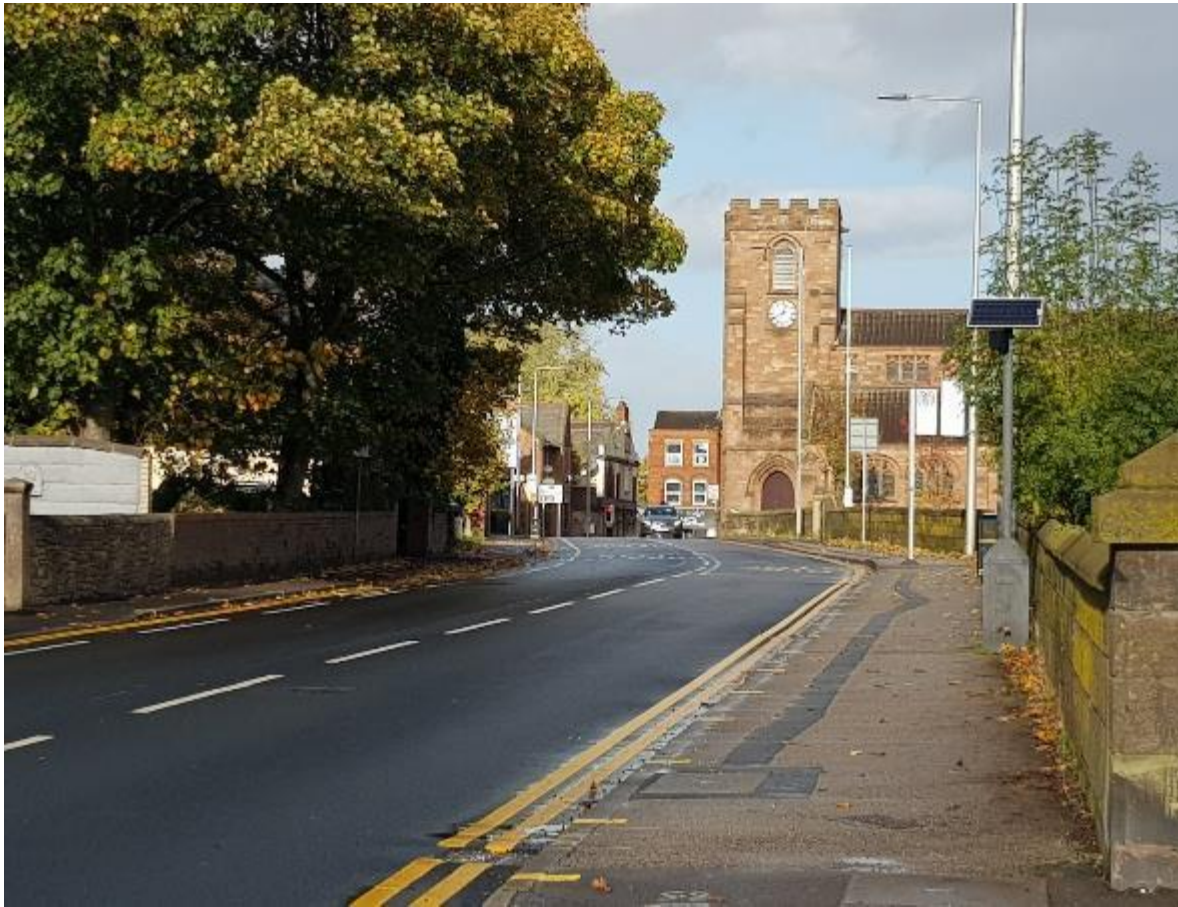
Picture 36. The tower of St Thomas Church and its presence as a gateway to the area

5.7 St Thomas's church and tower introduces the town centre to those arriving from the south. The churchyard with its low boundary wall provides a large open area which allows good views of the side elevation of the church and across to the mixture of attractive terrace houses that form the eastern border.

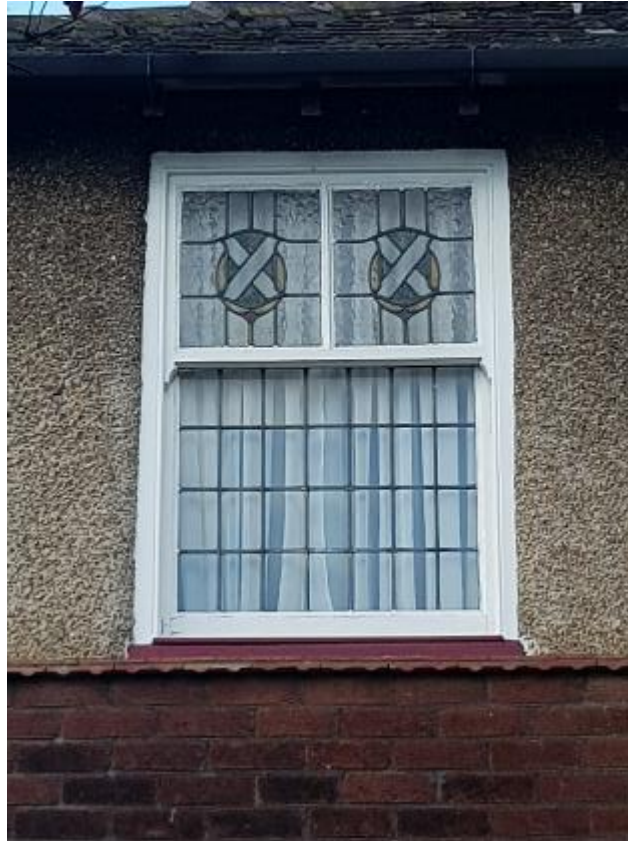
Picture 37 The leaded-coloured glass of the houses on Vicarage Road.

5.9 St Oswald's grounds used to be bounded to the east by a line of terrace properties along Warrington Road which included the Vicarage for St Thomas's. The terraces to the south of The Angel public house have been demolished and replaced with modern (c. 20 century) buildings. The presence of mature trees and other landscaping provides a 'green' visual link between the two churchyards. The 20<sup>th</sup> century housing around the corner of Warrington Road and Vicarage Road has little visual or heritage merit, except for the interest in two asymmetrical sets of semi-detached houses which retain original leaded coloured glass.

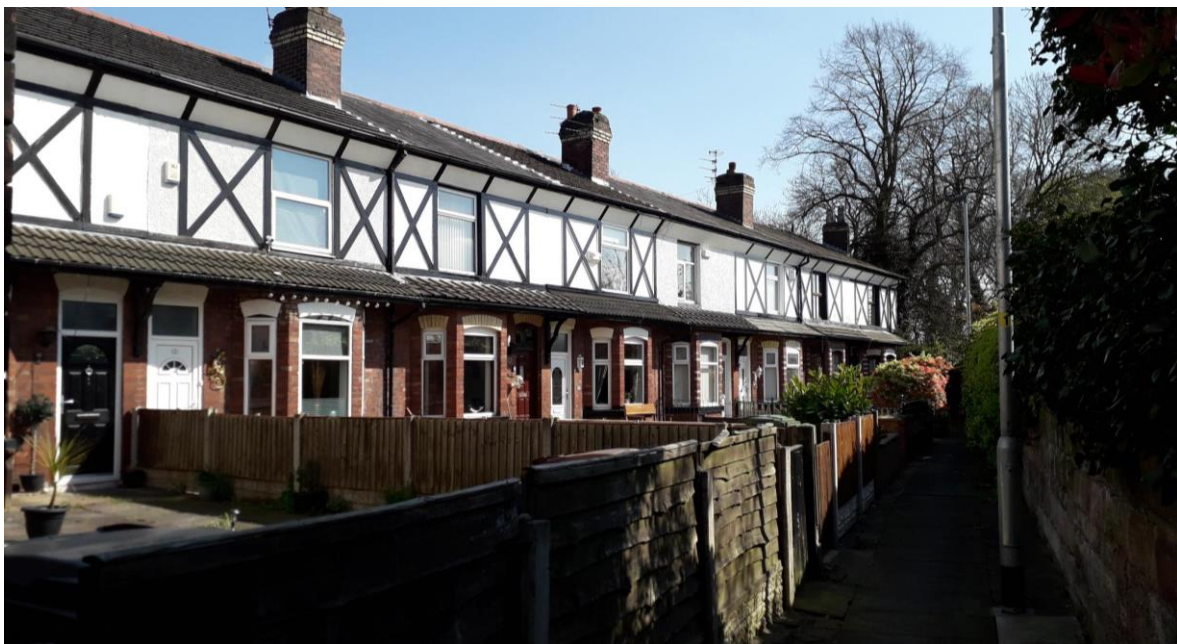
Picture 38. Church Terrace showing details of timber cladding and chimneys.
